Fire Research Group
Department of Mechanical and Mechatronics Engineering
University of Waterloo
Waterloo ON Canada N2L 3G1
E. Weckman, A. Topic, T. Sheehan and G.Hitchman

MARITIME EVALUATION OF AEROSOL FIRE KNOCK DOWN TOOLS

PART 2: TOXICITY AND CORROSION POTENTIAL

DRDC DOCUMENT NUMBER: DRDC-RDDC-2014-C32

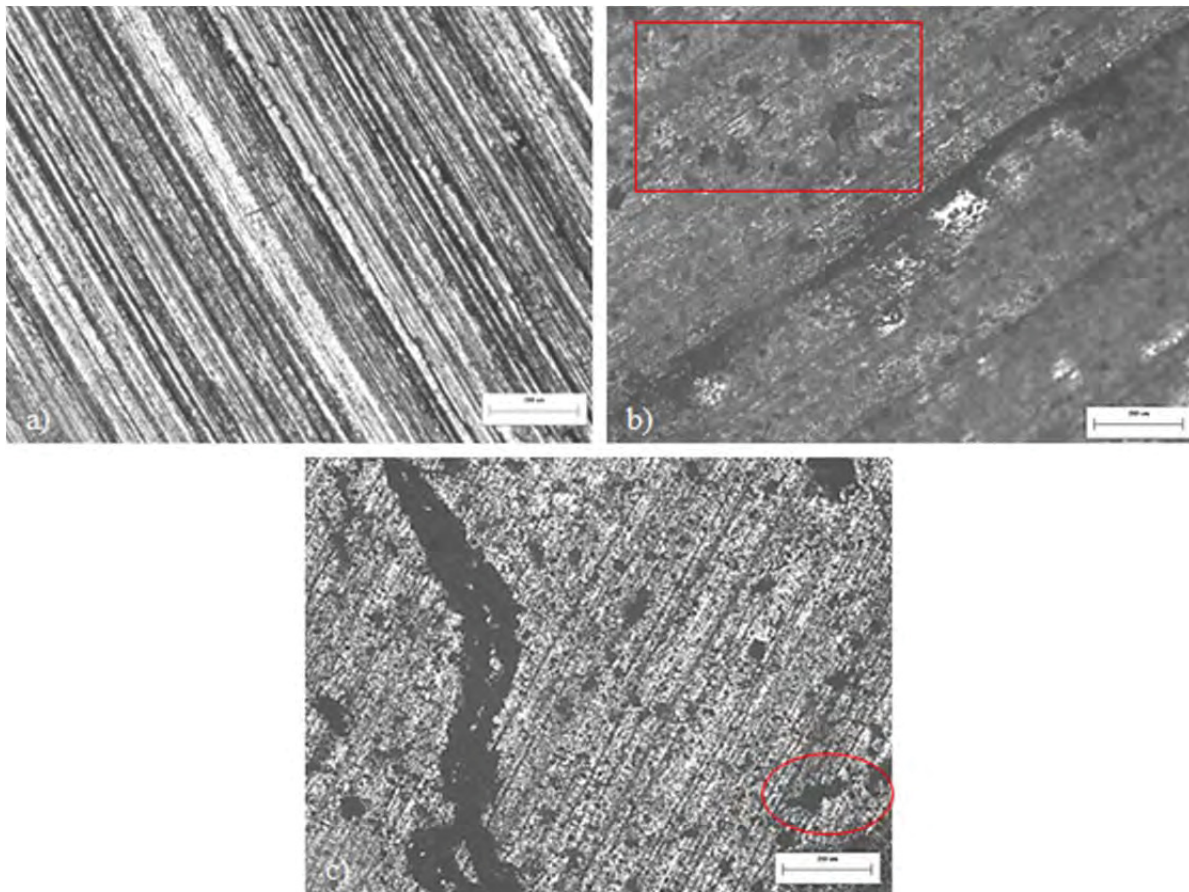
Figure 6-24: Surface of copper beryllium disc (50x magnification) a) reference specimen b) three months after exposure to DSPA 5-4 aerosol only c) two months after exposure to diesel fire with DSPA 5-4 suppression

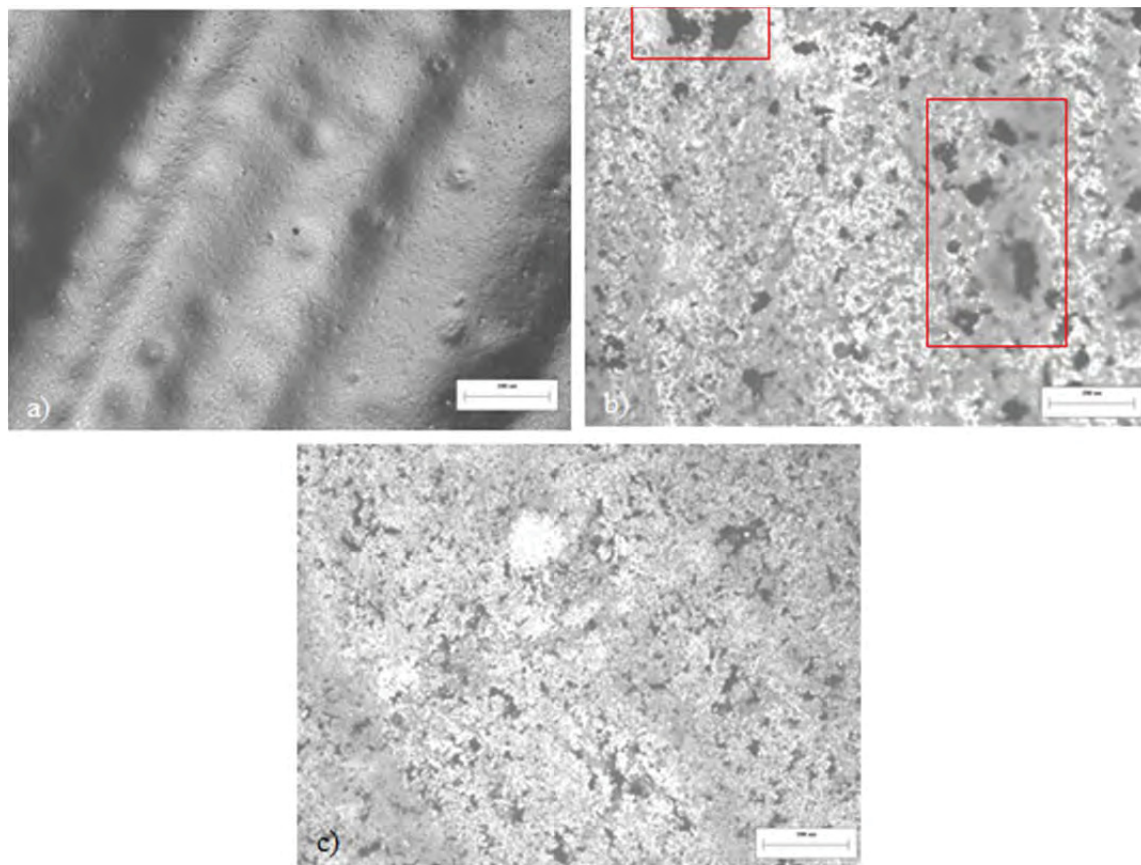
Figure 6-25: Surface of high tensile steel specimen (50x magnification) a) reference specimen b) three months after exposure to DSPA 5-4 aerosol only and c) two months after exposure to diesel fire with DSPA 5-4 suppression

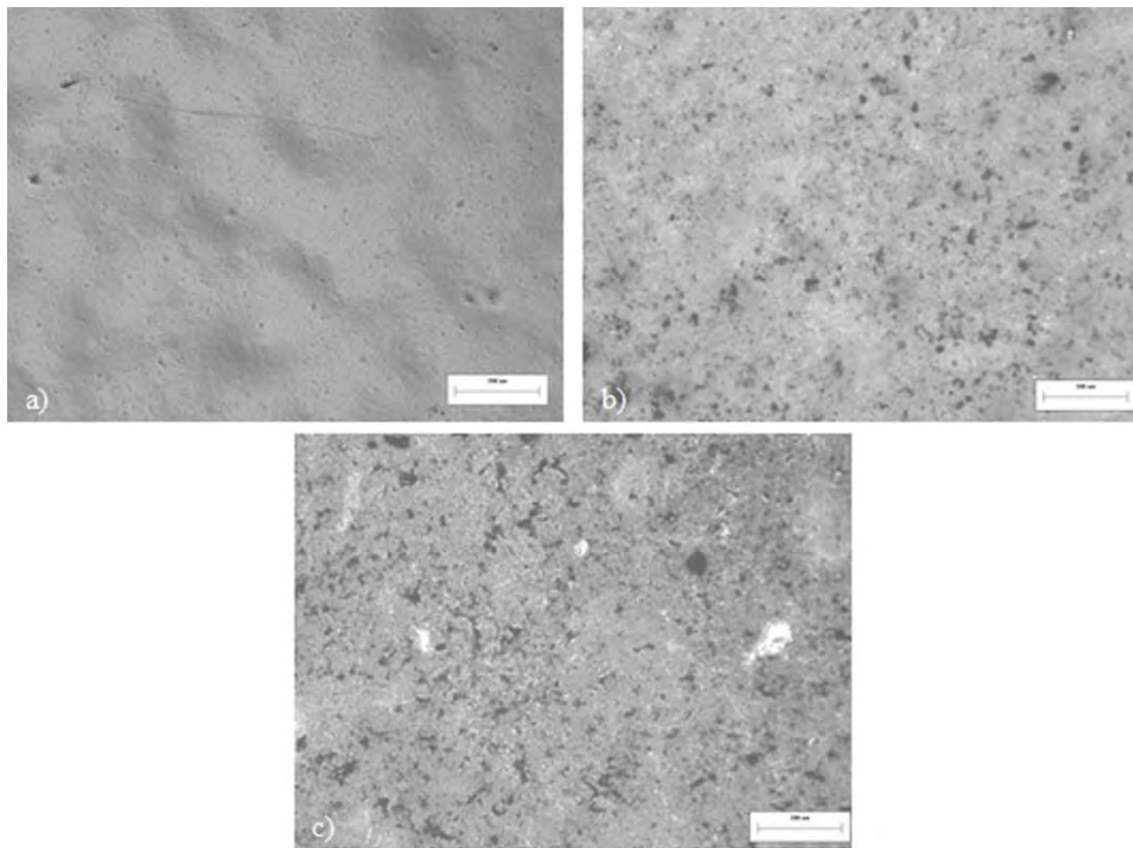
Figure 6-26: Surface of AISI 1018 mild steel specimen (50x magnification) a) reference specimen b) three months after exposure to DSPA 5-4 aerosol only and c) two months after exposure to diesel fire with DSPA 5-4 suppression

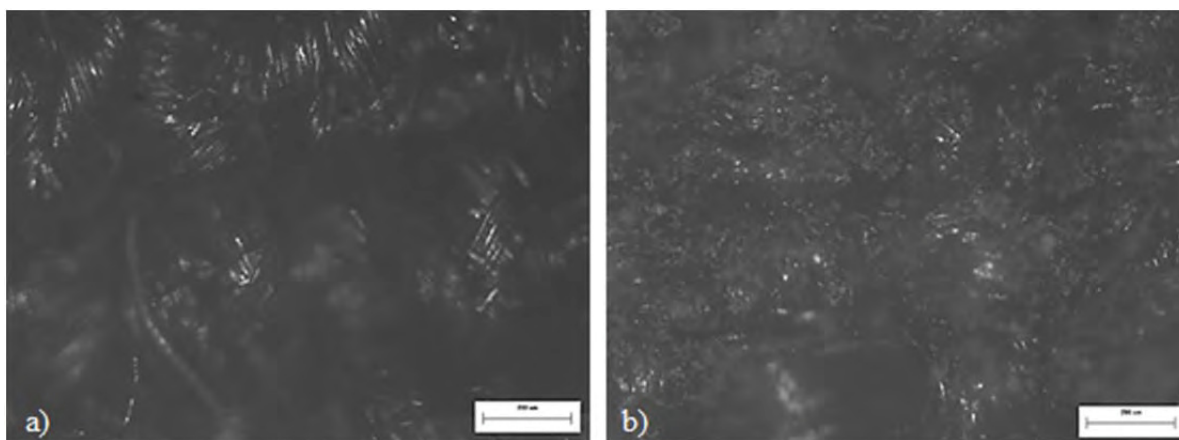
Figure 6-27: NOMEX fabric specimen (50x magnification) a) reference specimen and b) three months after exposure to DSPA 5-4 aerosol only

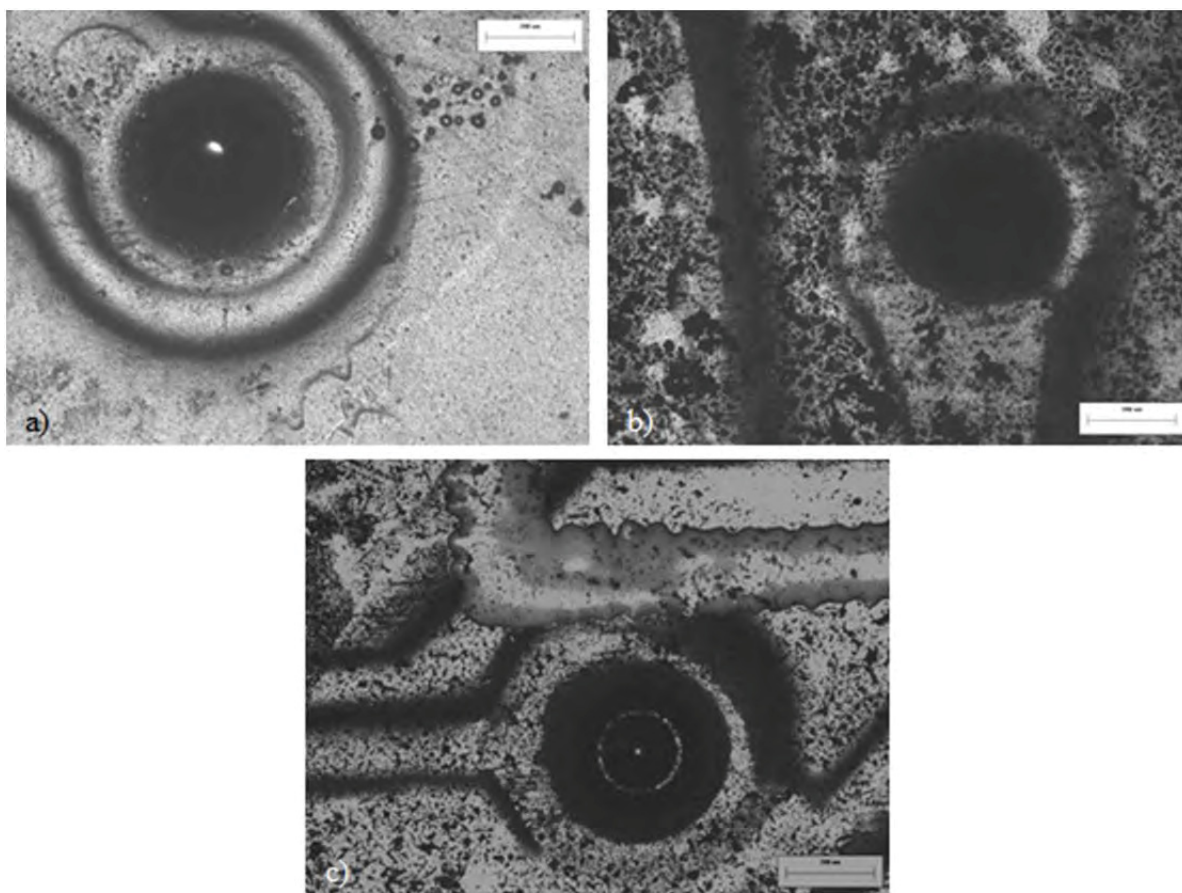
Figure 6-28: Connectors on computer circuit board (50X magnification) a) reference specimen b) three months after exposure to DSPA 5-4 aerosol only c) two months after exposure to diesel fire with DSPA 5-4 suppression

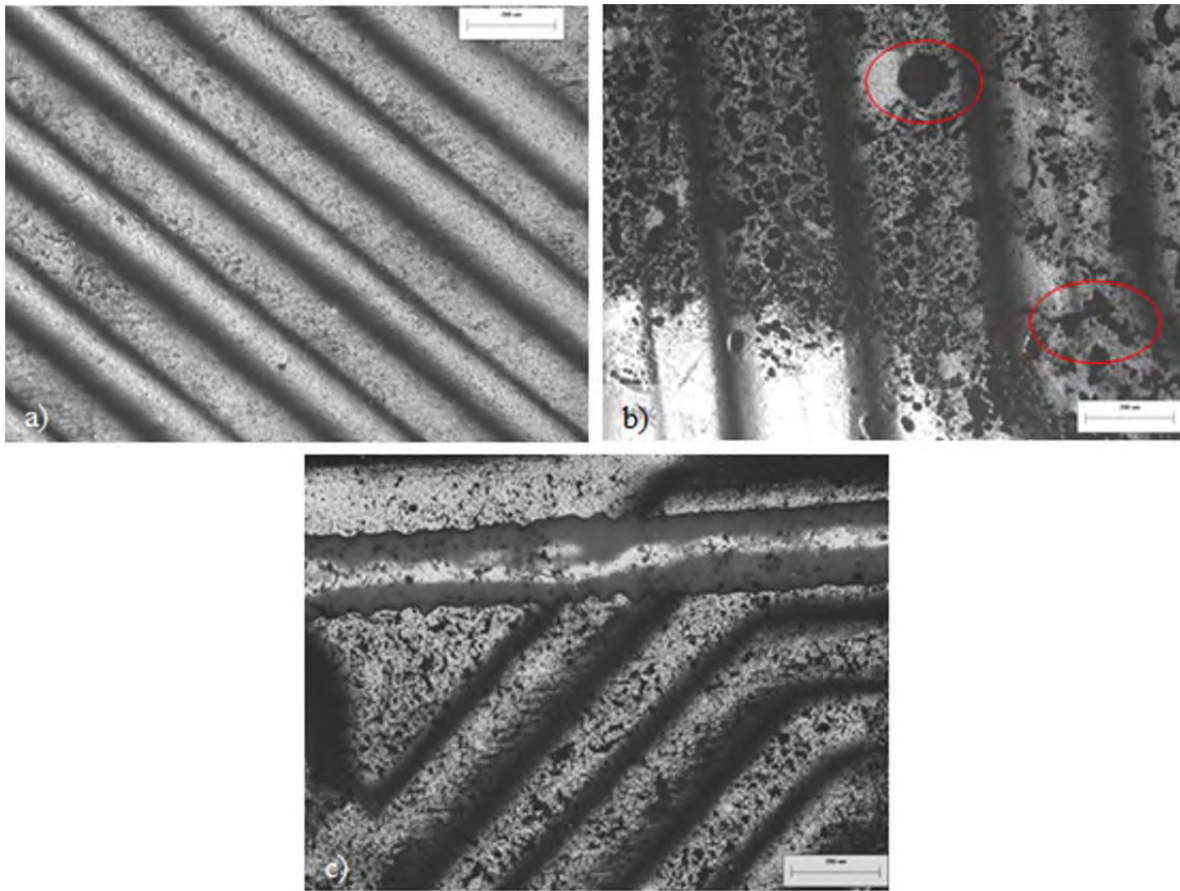
Figure 6-29: Conductive pathways on computer circuit board (50X magnification)
a) reference specimen b) three months after exposure to DSPA 5-4 aerosol only
c) two months after exposure to diesel fire with DSPA 5-4 suppression

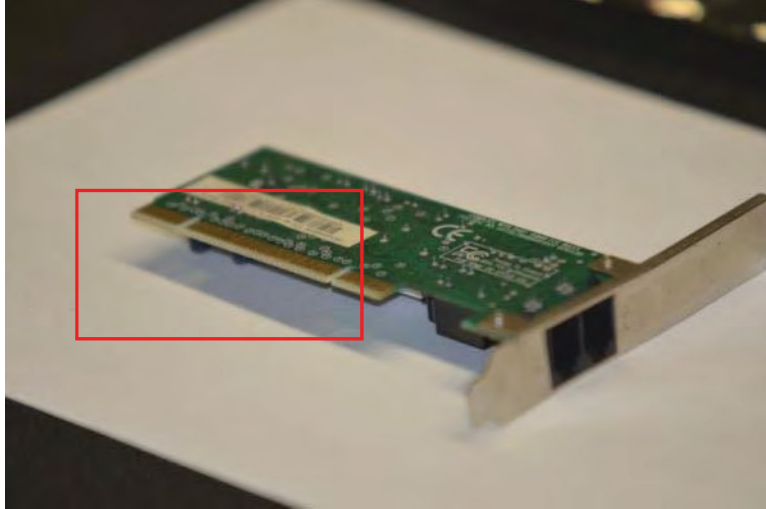
Figure 6-30: Computer Card after six months of exposure to DSPA aerosol agent

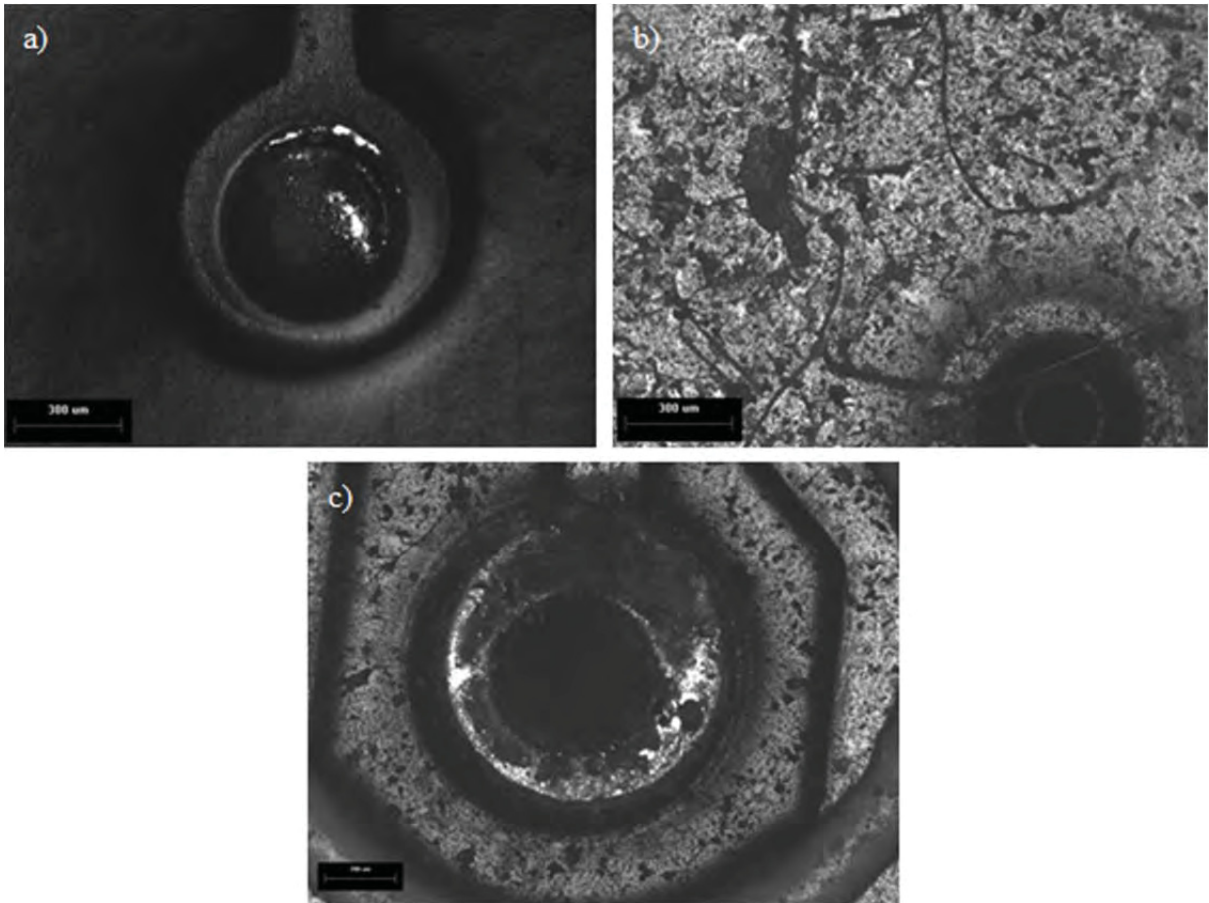
Figure 6-31: Connectors on computer circuit board (50x magnification) a) reference specimen b) section of board near connector six months after exposure to DSPA 5-4 aerosol only c) connector six months after exposure
